# Case Study

## Power Quality Control in an Industrial Estate

Ekemon Suebyam

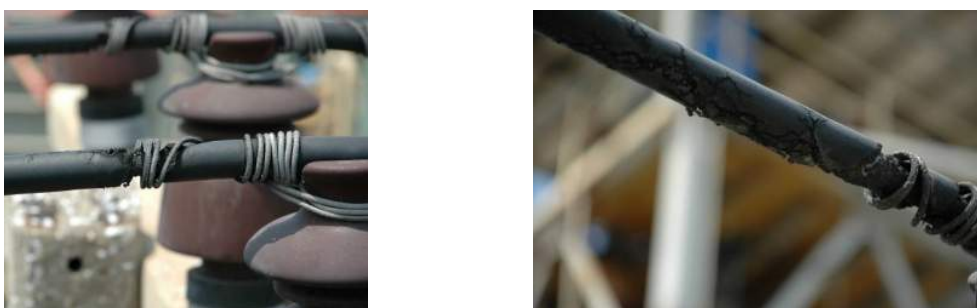
**Figure 4:** *Deterioration of cable insulation which is close to a cooling tower.*

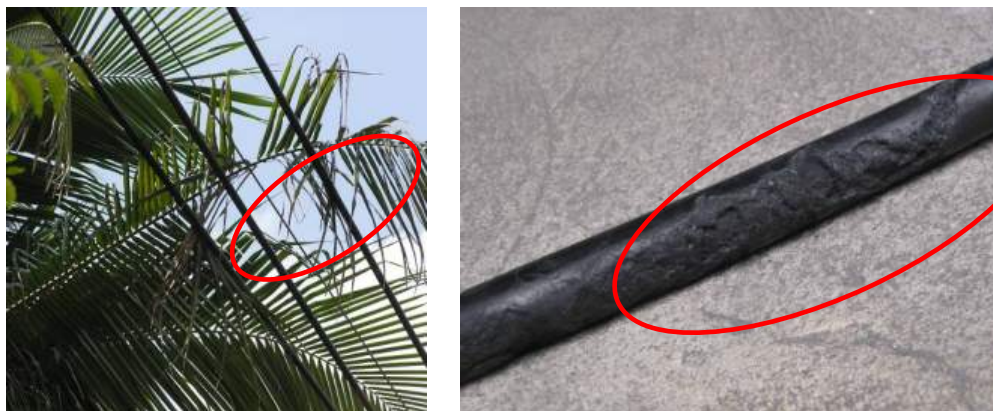
Normally, the gradual deterioration of equipment is unavoidable so preventive maintenance is very important to ensure that breakdowns and failures are avoided. Using better quality equipment, correct installation techniques, and avoiding external factors (such as illustrated in Figure 5) which can promote deterioration help to protect the system from degradation.

**Figure 5:** *Insulated cable intermittently touching a tree (left) leads to deterioration of insulation (right).*

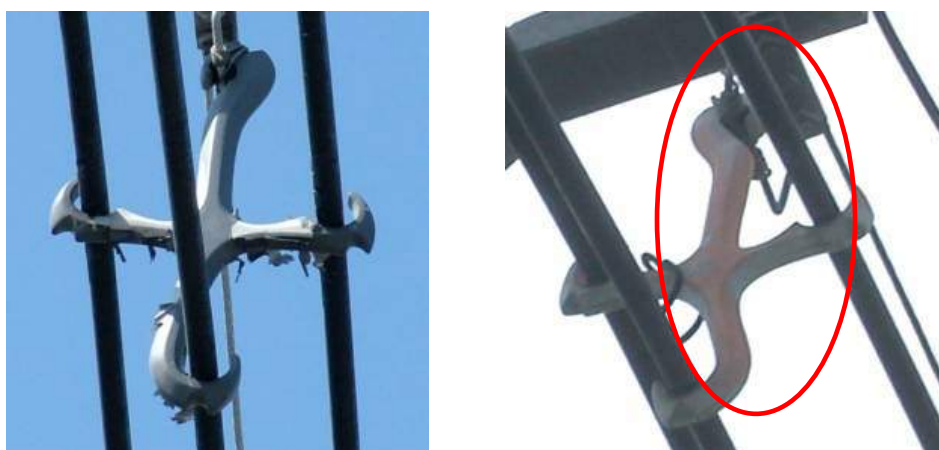
For example, pin-type insulators and spacers have a short lifetime and are not suitable for use in 24 kV systems because of their poor insulation properties and rapid deterioration. Figure 6 shows a ceramic spacer after two years service. This promotes partial discharge phenomena and degrades the cable insulation (see Figure 7). A pin-post-type insulator, as shown in Figure 8, has better insulation properties and is more durable to outside environment.

**Figure 6:** *Gray coating was removed (left) and change to be orange color (right).*

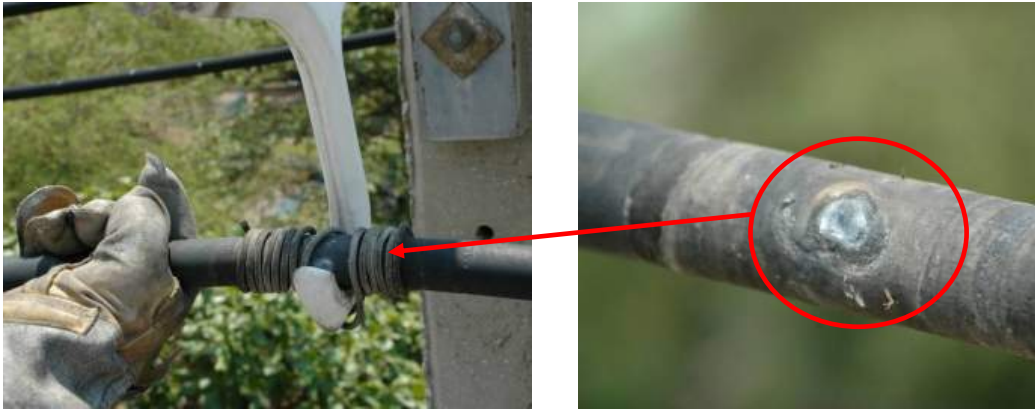
**Figure 7:** *Partial Discharge site (left) and resultant cable damage (right).*

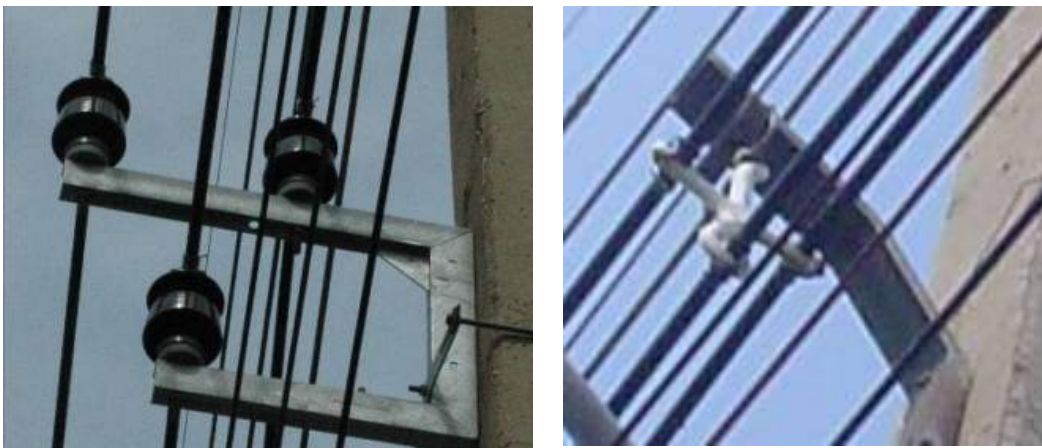
**Figure 8:** *Installation of Pin & Post insulation (left) to replace a spacer (right).*

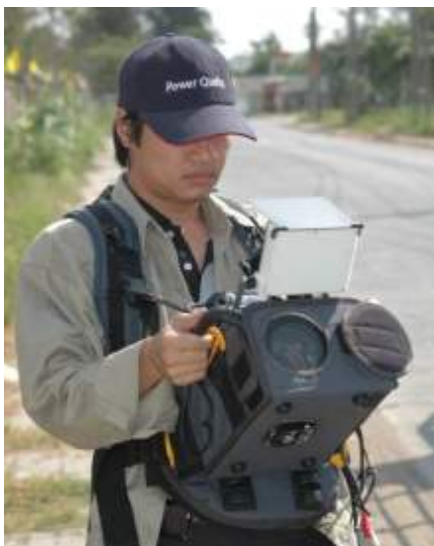
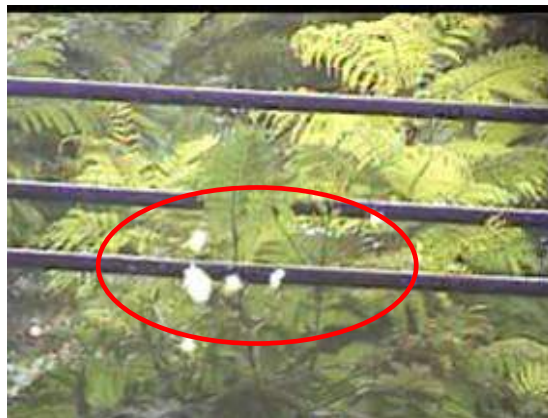
**Figure 10:** Optical partial discharge detector (left); partial discharge caused by cable touching a tree (right).

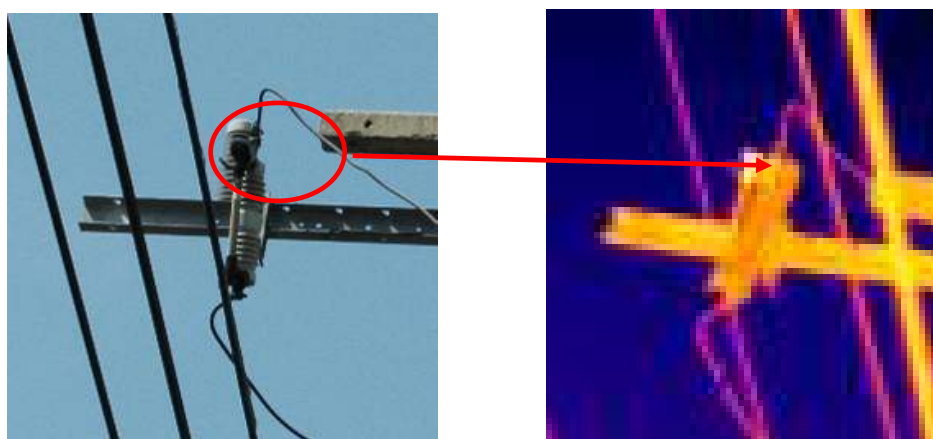
**Figure 12:** *Elevated temperature at the top contact point of a fuse.*

Figures 11 and 12 show the use of a thermal scanner and its inspection result. This instrument easily finds connection points that are at a higher temperature than surrounding areas, quickly locating hot spots. Once a problem has been identified and corrective action completed, a maintenance plan should be put in place requiring at least two annual inspections.
