# Case Study

## Power Quality Control in an Industrial Estate

Ekemon Suebyam

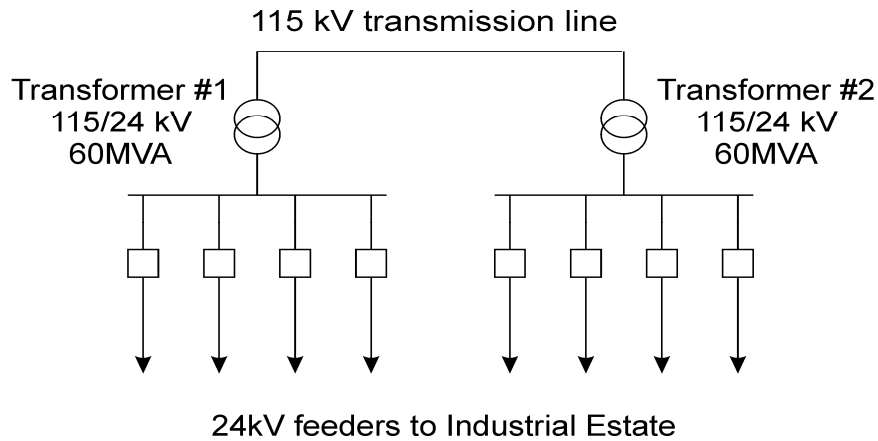
A substation supplies power to factories in an industrial estate through 24 kV feeders. The substation has two 60 MVA transformer to step down from the 115kV external transmission lines to 24 kV. Note that the 24 kV busses from each transformer are separate; they are not connected to each other. See Figure 1 for a single line diagram.

**Figure 1:** Substation and Feeder system 24 kV at Industrial Estate

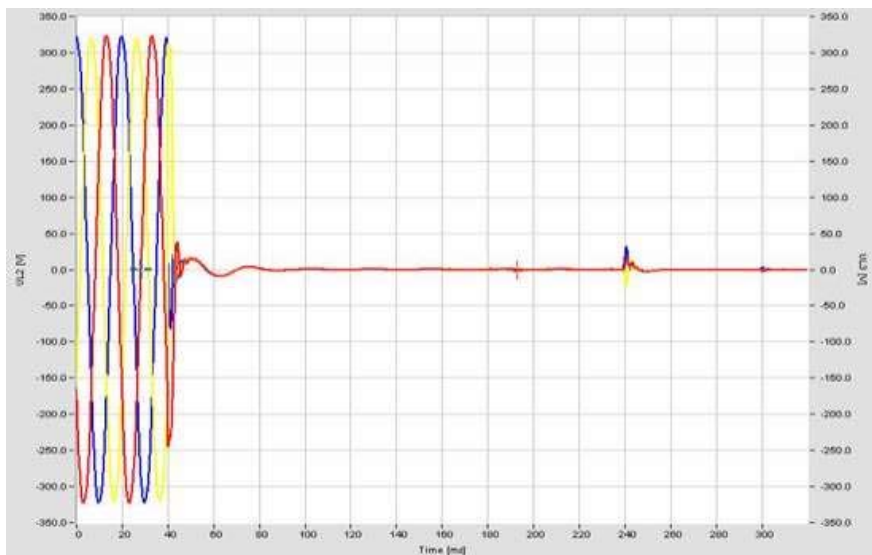
There are a significant number of customers connected to each 24 kV feeder. If there is a short circuit in any feeder, all customers on that feeder will lose power (see Figure 2) while customers on the other feeders may experience a voltage dip (see Figure 3). In general, more customers will experience a voltage dip than will lose power. The consequences of a voltage dip will vary from customer to customer depending on the sensitivity of their equipment and processes.

**Figure 2:** Electrical waveform when power interrupted

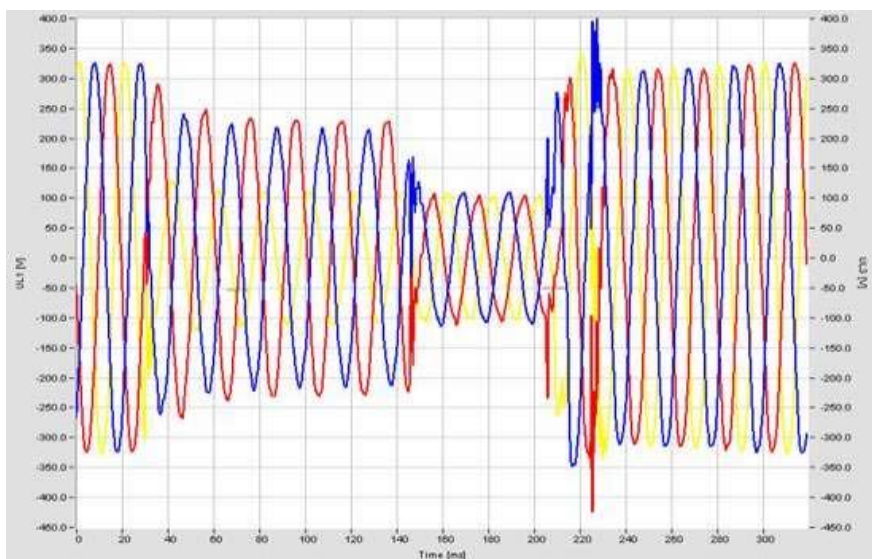
**Figure 3:** Electrical waveform during voltage dip

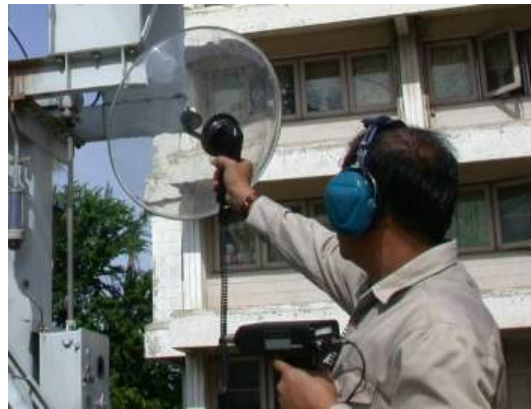
For example, detection of partial discharges – which may lead to breakdown of the insulation – can be detected by non-contact acoustic or optical methods, as shown in Figures 9 and 10 respectively.

**Figure 9:** *Acoustic partial discharge detector.*
